# SPRINGWOOD LAKE DAM

D0558

Start Date: 11/03/2025      Completed Date: 11/06/2025

## Dams Preliminary Inspection Form

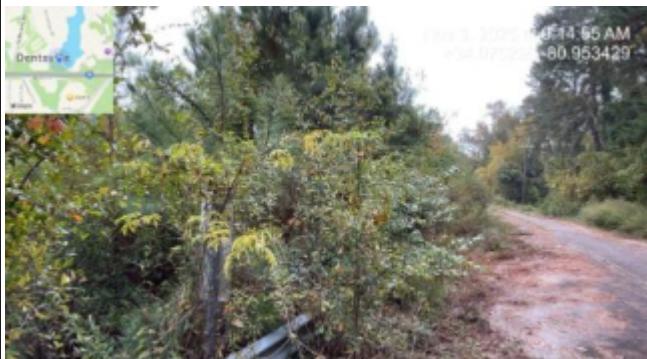
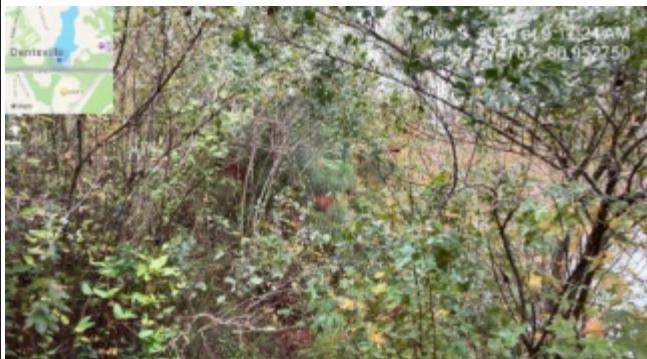
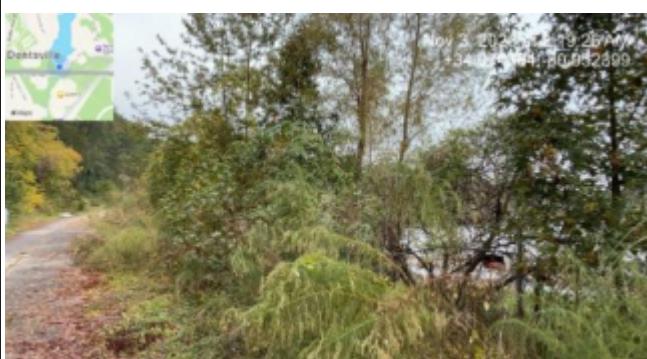
No grass cover.

Dense brush, woody vegetation, and trees less than 4" in diameter along the entirety of the upstream slope. Condition prevented full inspection.

Several trees approaching or at the 4" diameter threshold of requiring a permit to remove.

Brush, woody vegetation, and small trees should be cut and removed from the upstream slope, downstream slope, and crest.

More complete grass cover should be established on the slopes.

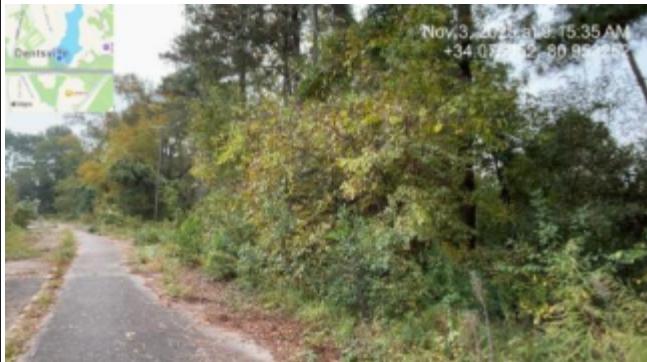
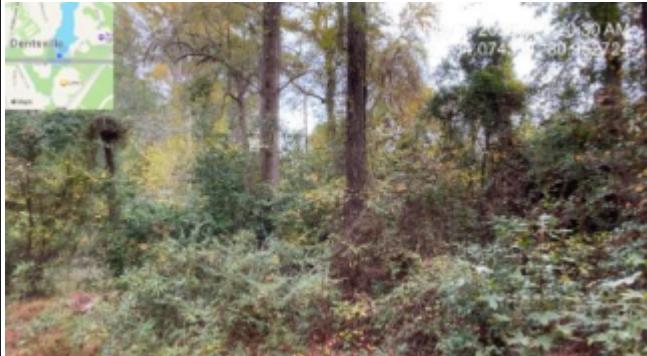
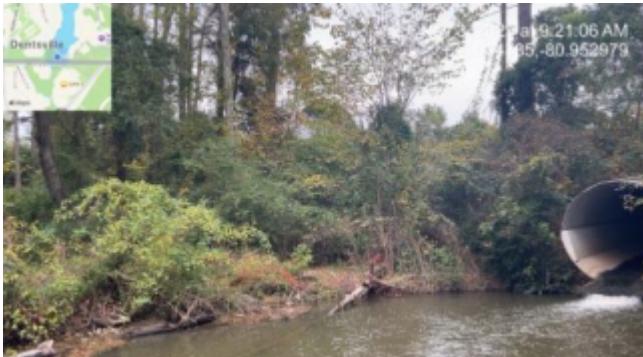
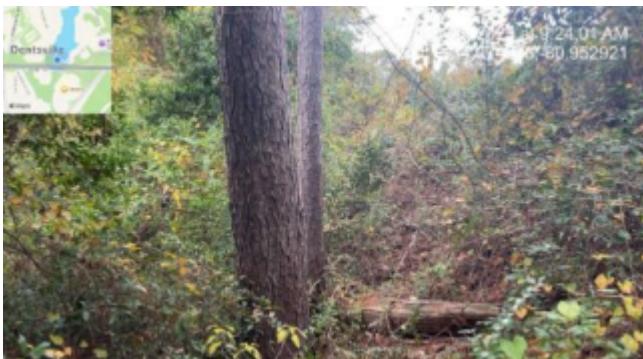
No grass cover on the downstream slope.

Dense brush and woody vegetation on the downstream slope.

Trees greater than 4" in diameter observed on the downstream slope.

- Repair the spillway, conduit, outlet, and sinkholes.
- Repair erosion greater than 12" in depth on the downstream slope.
- Evaluate and repair the cracked auxiliary spillway.
- Develop and implement a tree management plan for trees greater than 4" in diameter.

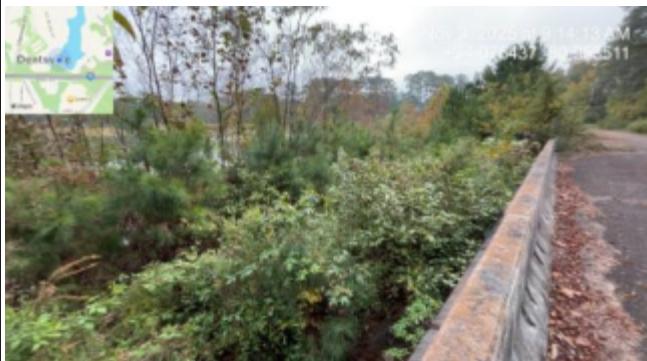
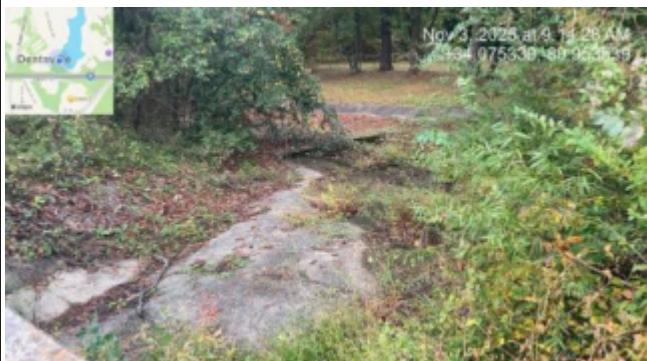
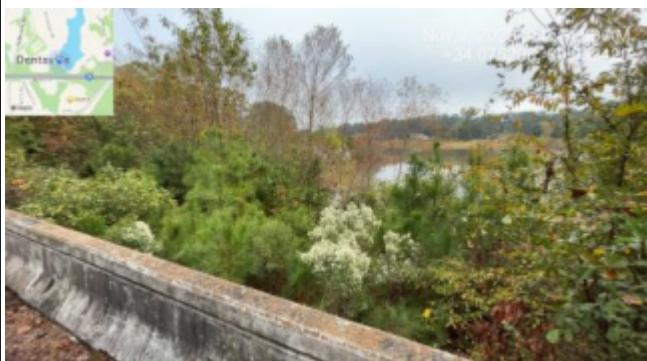
Dense vegetation growing in the approach area.

Cracks in the concrete should be evaluated and repaired.

Dense vegetation and small trees growing in the spillway.

Cut and remove vegetation from the auxiliary spillway.

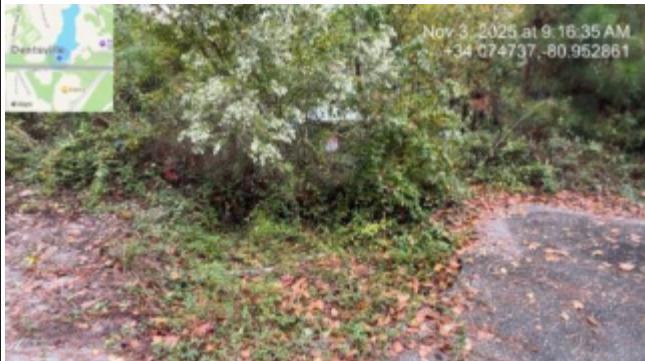
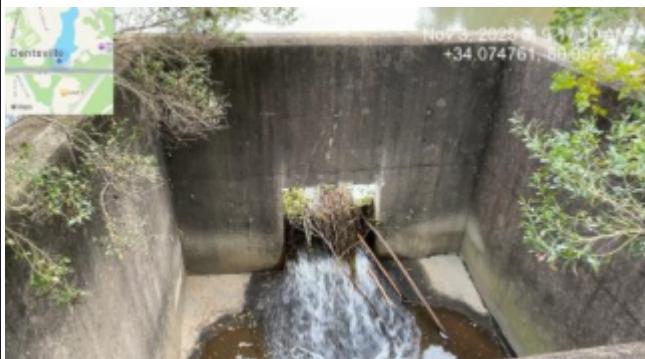
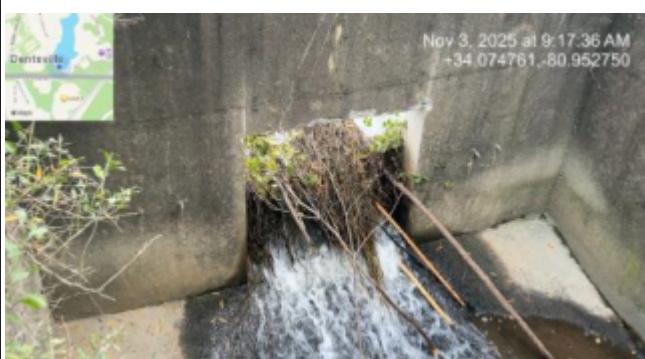
Square hole cut in the concrete riser to drain lake through the emergency repaired primary conduit.

Significant debris has the opening at the bottom of the riser 1/2 to 2/3 blocked.

None since the emergency repairs made to cut an opening in the riser.

Clear debris from the hole cut in the riser.
