# SPRINGWOOD LAKE DAM

D0558

Start Date: 11/03/2025      Completed Date: 11/06/2025

## Dams Preliminary Inspection Form

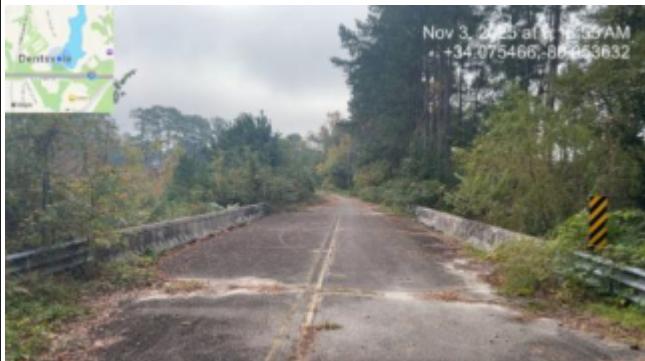
Photo Taken: 11/3/2025 9:13:55 AM  
GPS Latitude: 34.07546666666667  
GPS Longitude: -80.95362777777778  
GPS Altitude: 74.611145038168 meters
